SCAMP TRAILER WIRING-A:

4/30/2014

SCAMP TRAILER WIRING NOTES:

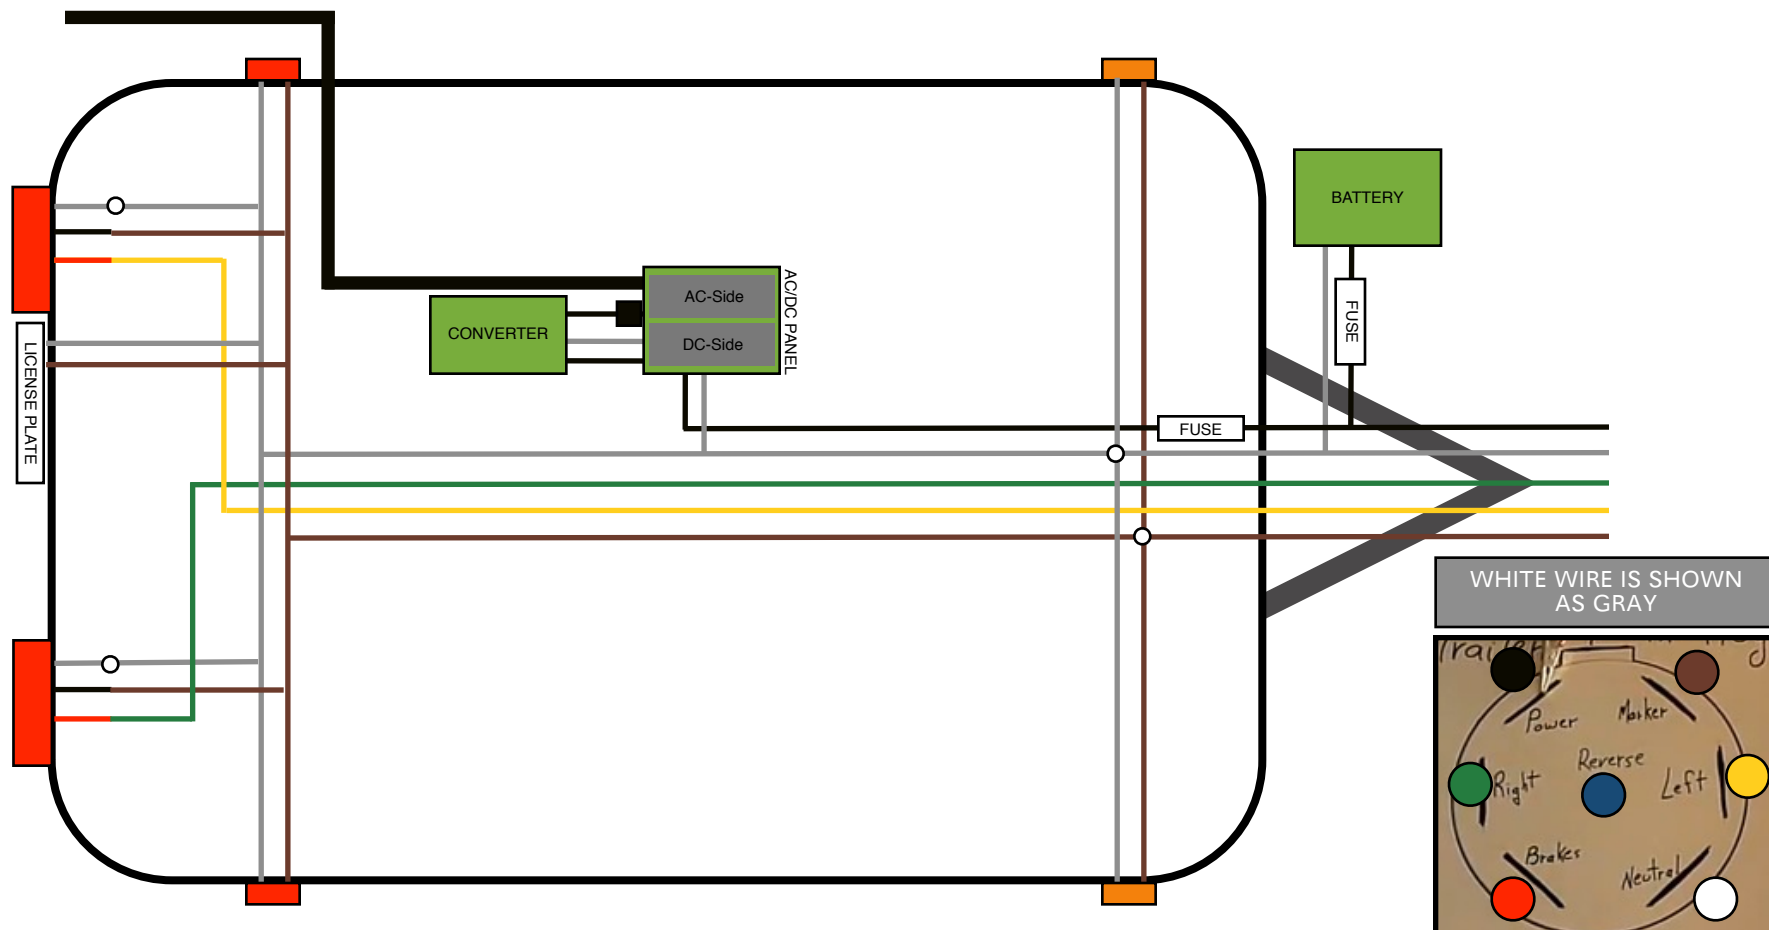
- from vehicle to all running lights
- from shore power (30 amp) to AC/DV panel
- from vehicle/battery to AC/DC panel

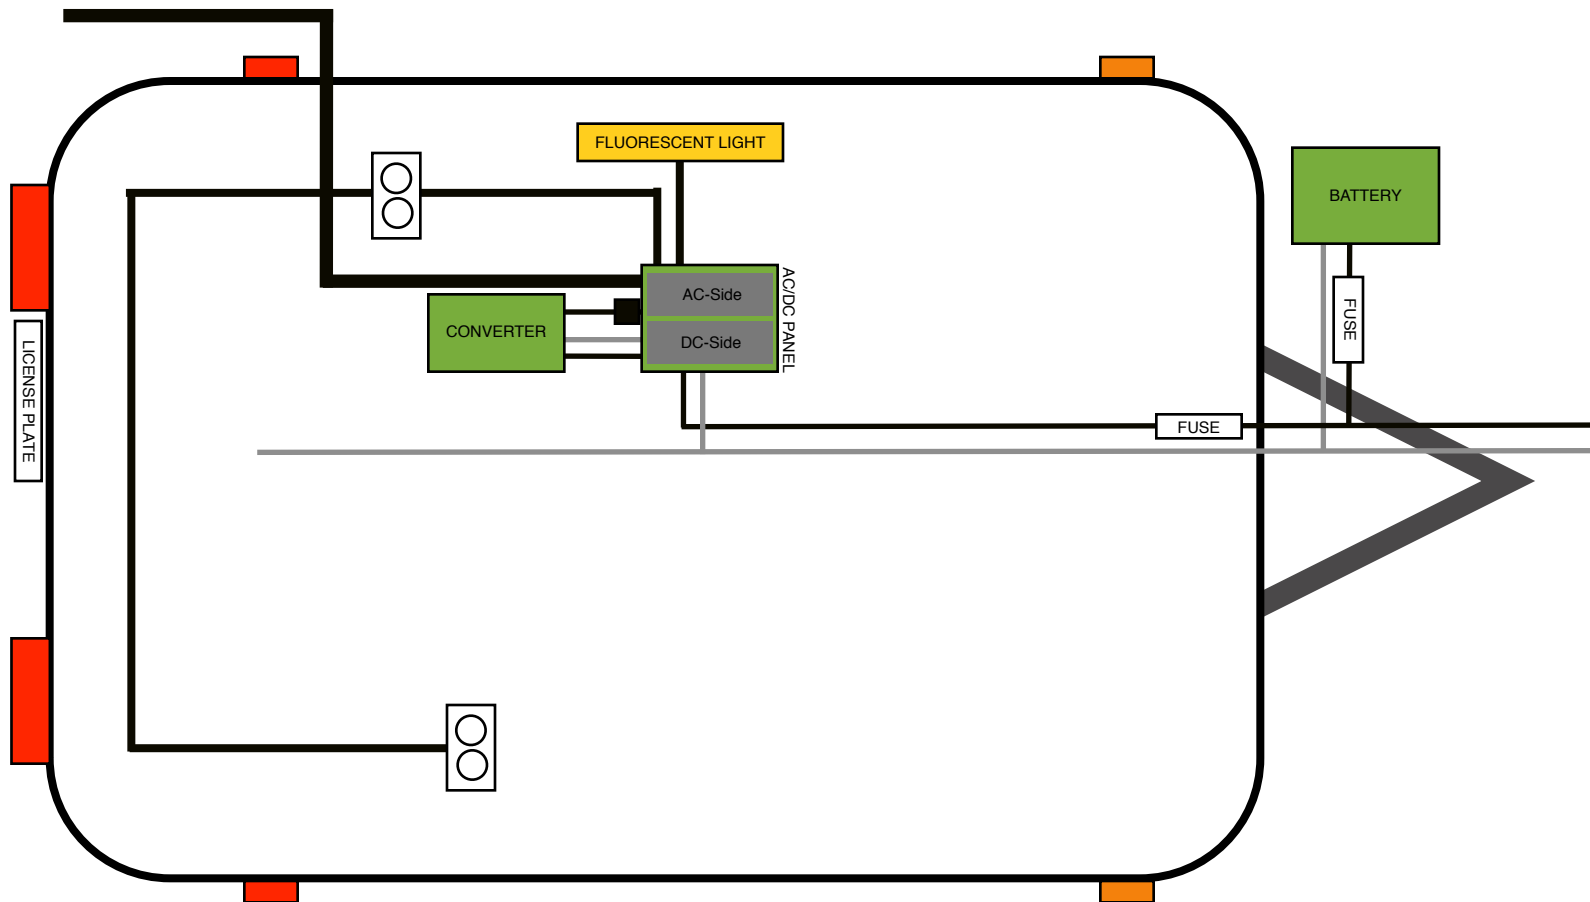
SCAMP TRAILER WIRING-13:

- juice from AC (side of) panel
- only operable when plugged into shore power (30amp)

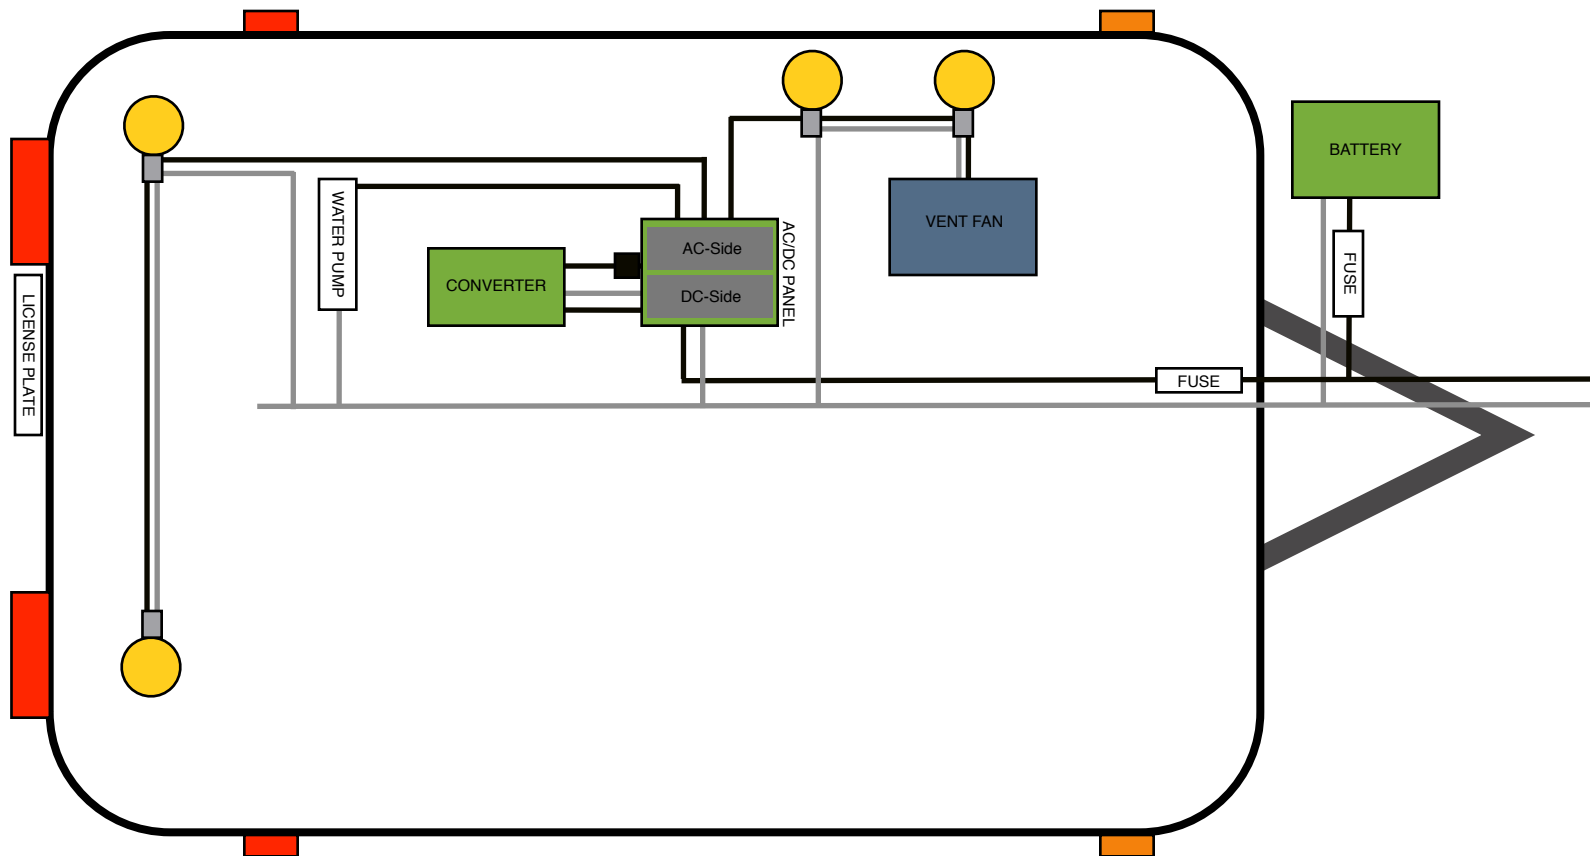
SCAMP TRAILER WIRING-C:

- juice from DC (side of) panel
- from DC panel to lights and other 12V accessories (water pump as example)
